J-2296-07

April 28, 1999

Re: First Quarter 1999 Performance Report
Avery Landing Recovery System

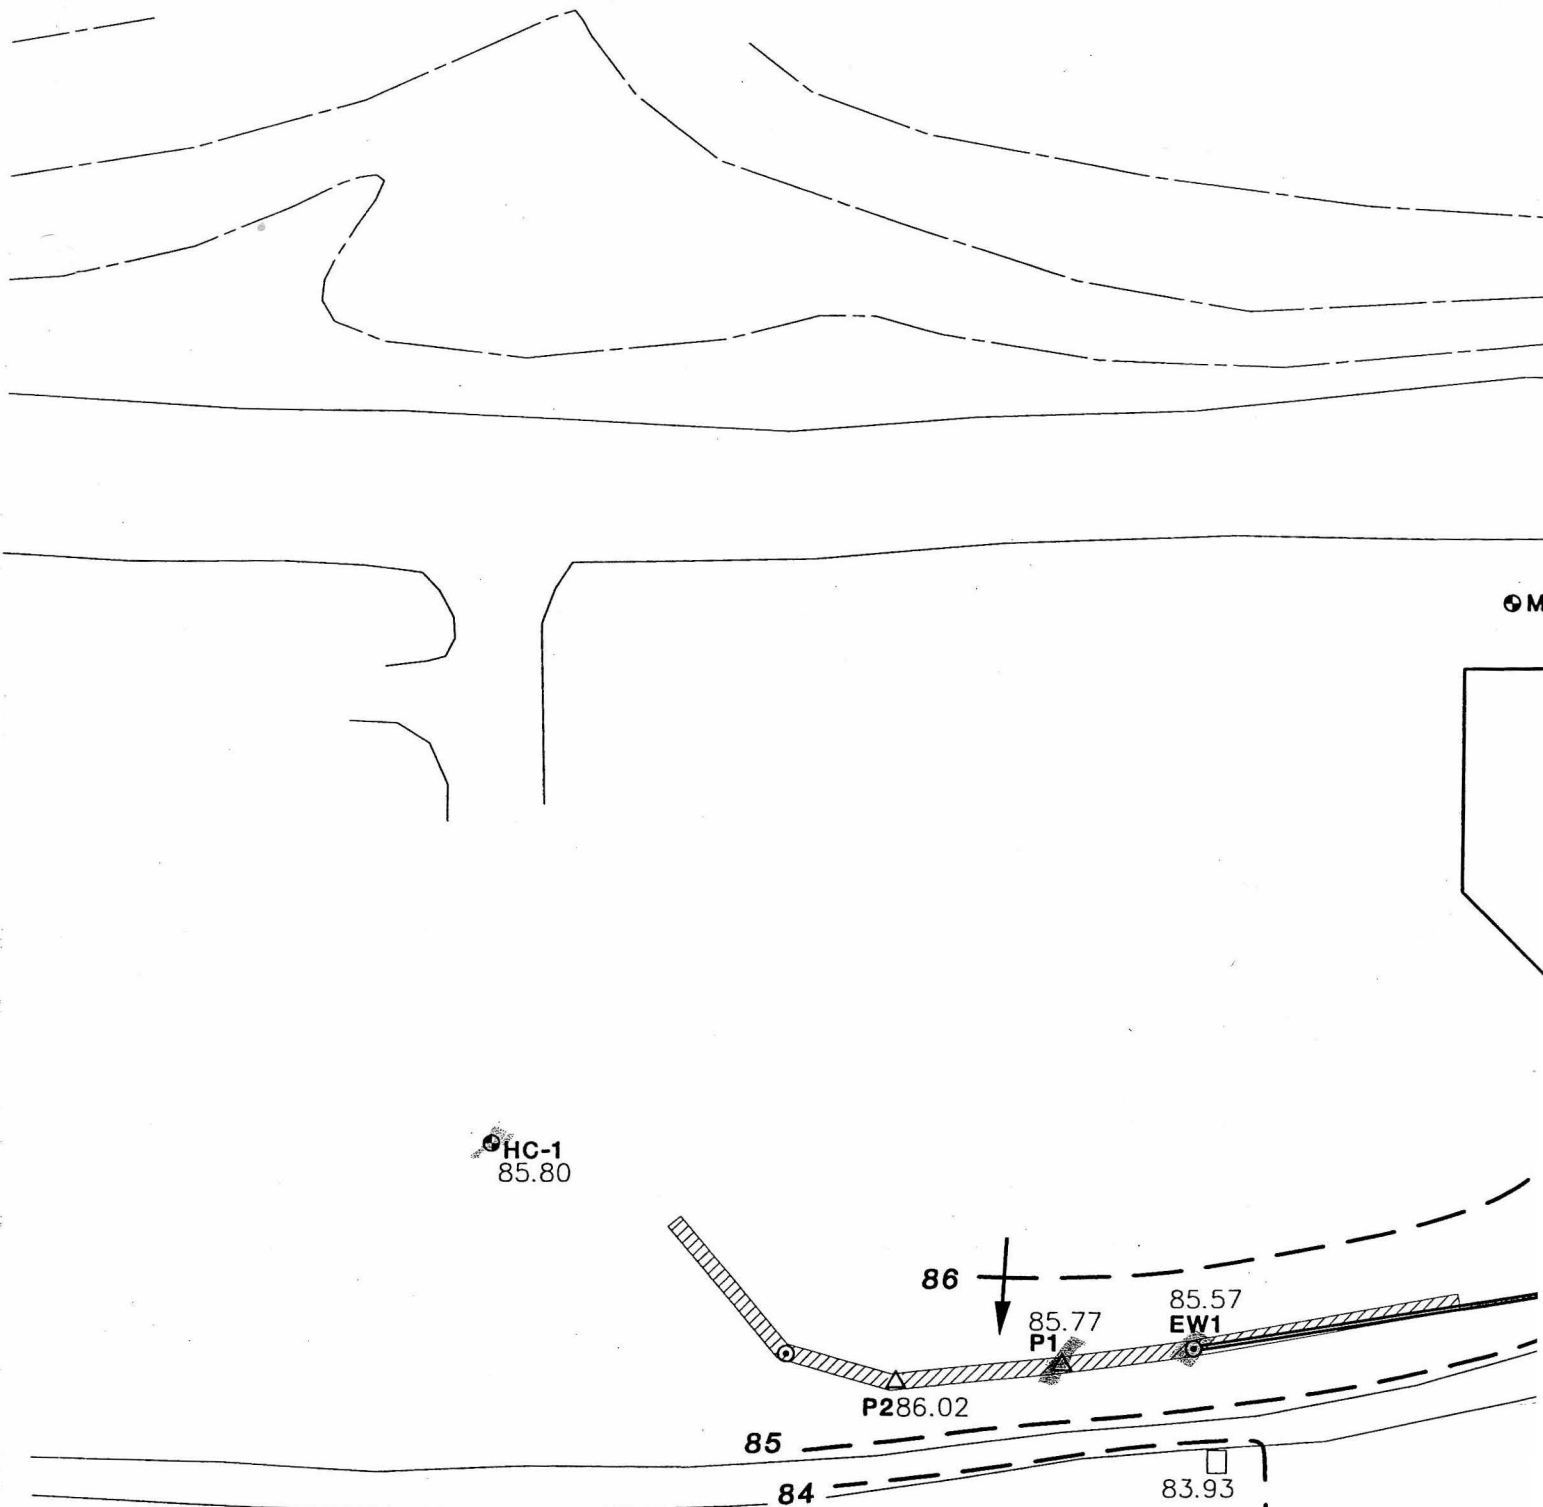
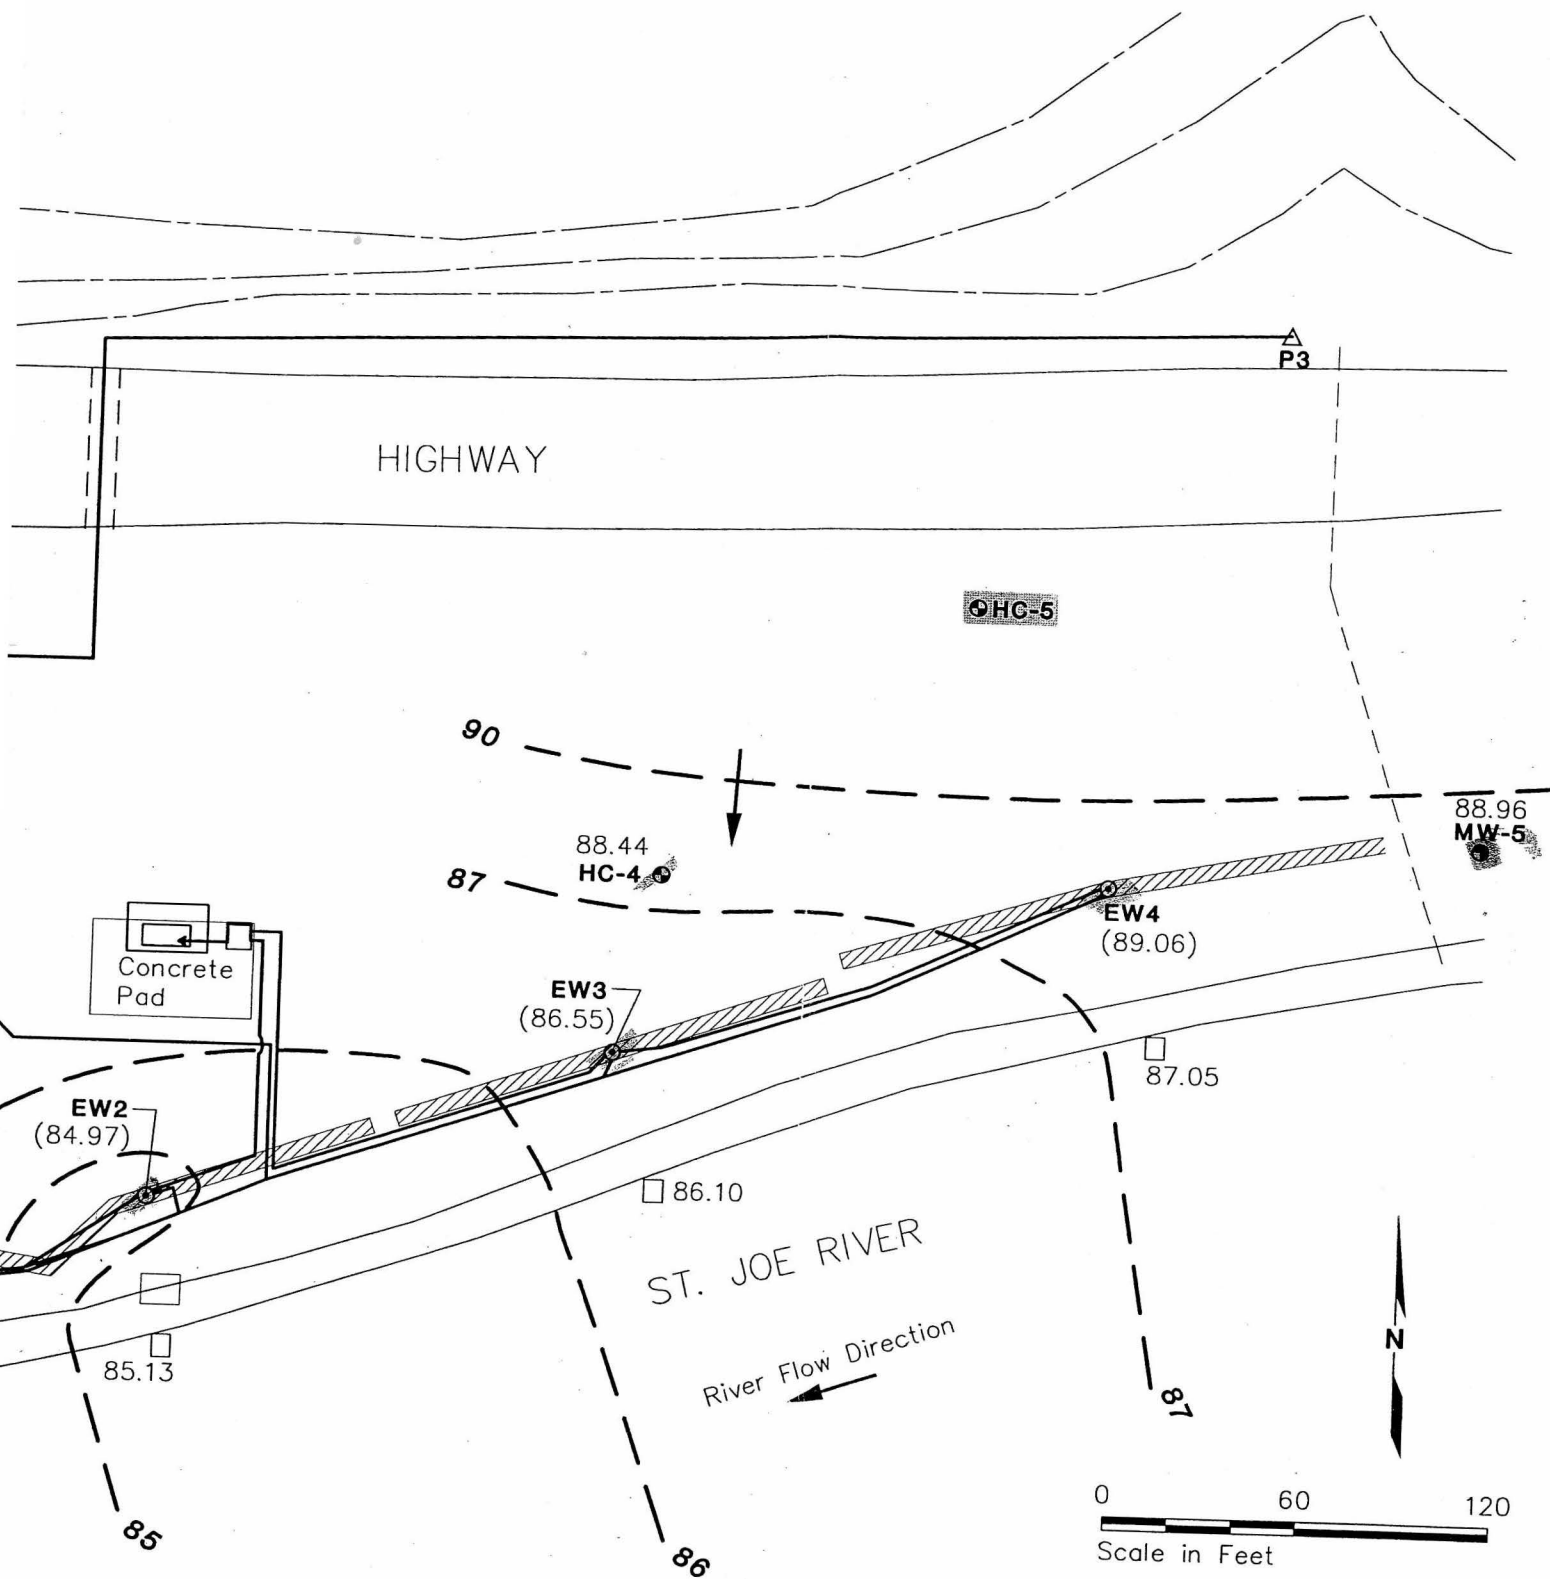
Figure 1

Three extraction wells (EW-2 through EW-4), three monitoring wells (HC-1, HC-4, and MW-5), and one piezometer (P-1) were monitored on March 18, 1999. At each monitoring location, depth to product and depth to groundwater measurements were performed using a Flexidip, a free product measuring device. The groundwater elevations at EW-1 and P-2 were calculated from measured elevations at surrounding wells. The river elevation adjacent to extraction well vault EW-3 was also monitored by measuring the elevation difference between the top of the vault and the river. The river elevations at the remaining three extraction well vaults were calculated based on the average slope of the river bottom and the distance between vaults. These measurements and calculations are presented with those of previous monitoring rounds in Table 1. Well locations and current groundwater contours are shown on Figure 1.

- ▶ EW-1 is no longer in use, as described in the 1998 Annual Report;
- ▶ EW-2 was operating and maintaining groundwater capture as indicated on Figure 1;
- ▶ EW-3 was operating, but was not maintaining groundwater capture. This could be the result of high groundwater flow due to spring runoff; and
- ▶ EW-4 was not operating during the March 18 site visit because of pump failure. During the site visit on April 6, 1999, the motor and pump had been replaced, and EW-4 is currently operating.
